Re: Graniterock Conditional Use Permit City File No. CP00-03-009; 2010 Annual  
Revegetation Monitoring Report

## Berryessa Asphalt Recycling Plant Riparian Revegetation Project

### Year 5 (2010) Monitoring Report

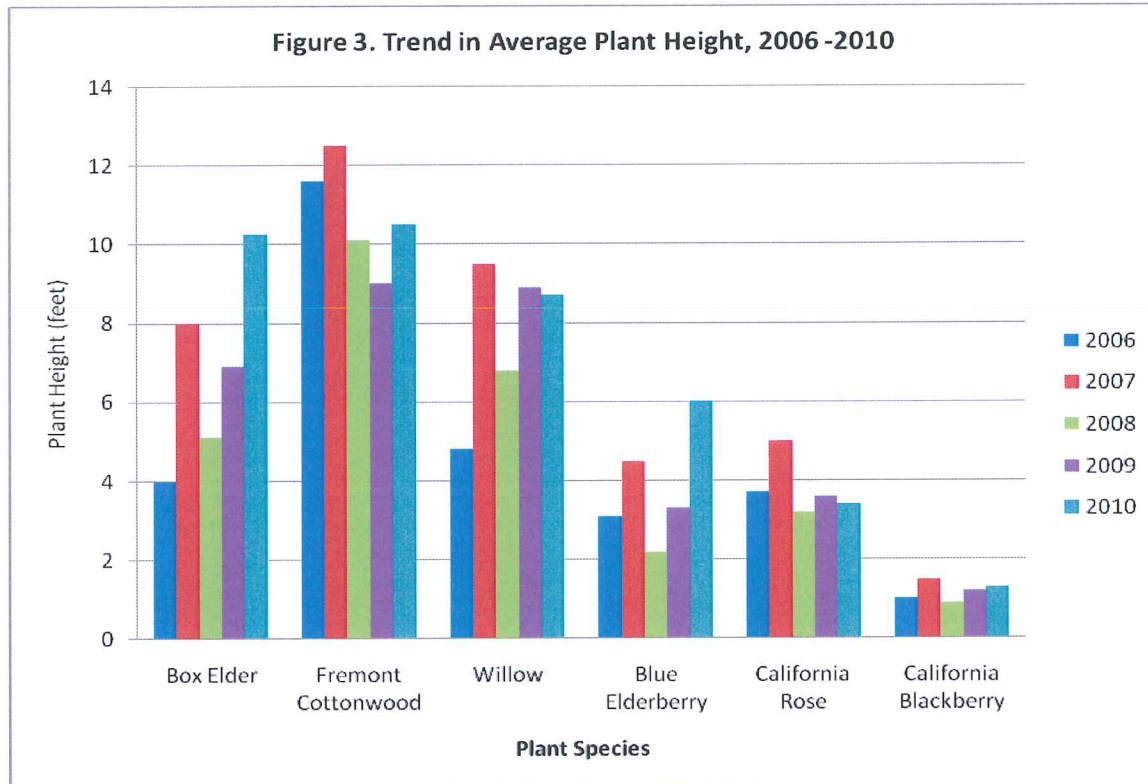
The trend in plant height, in feet by species, from Year 1 (2006) to Year 5 (2010) is depicted in Figure 3. The average plant height for most plantings increased in 2010. A 5-year old Fremont cottonwood which is over 30 feet tall is depicted in Figure 4.

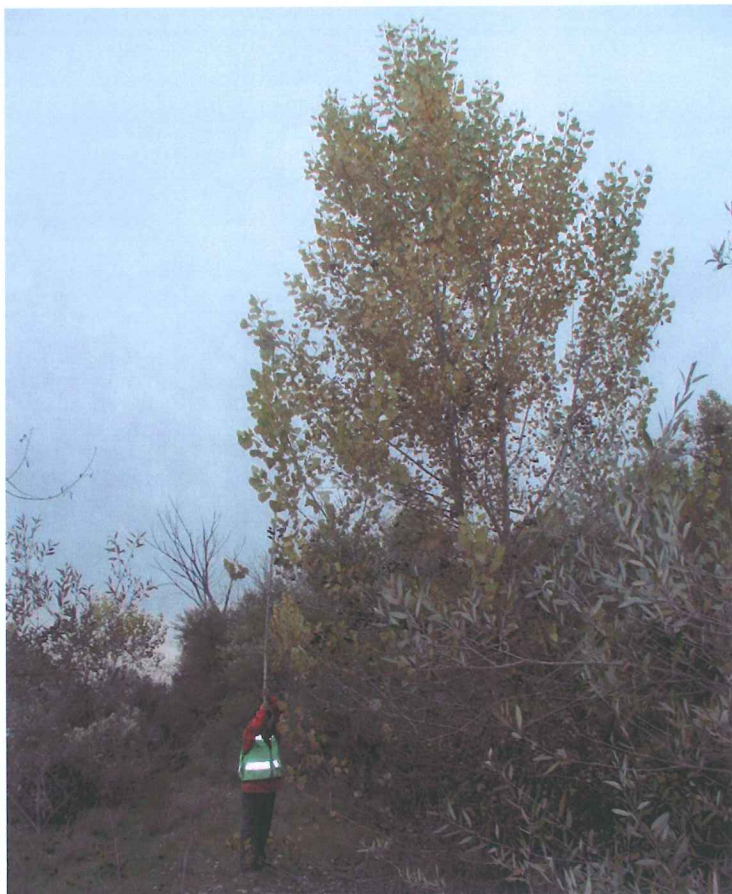
Figure 4. Fremont cottonwood exceeding 30 feet tall in Year 5, December 2010.

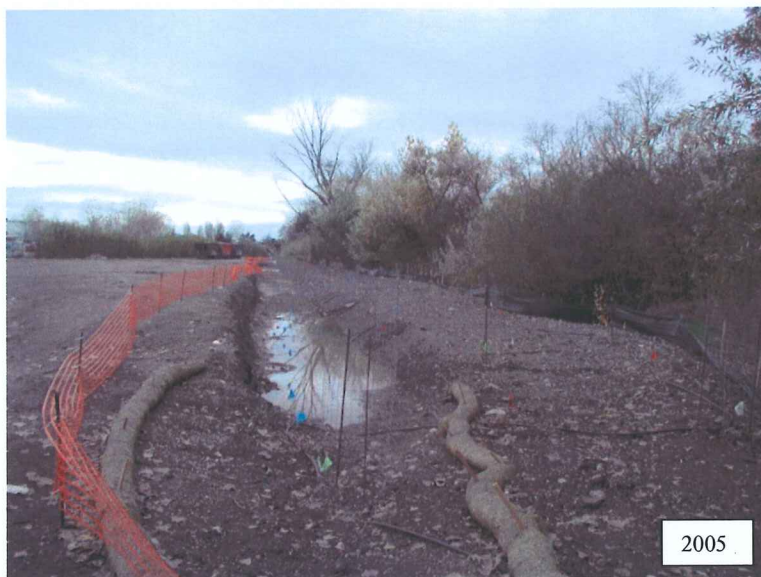
Figure 5A. Photo Station #1, taken from southern end of revegetation area, looking northward along the top edge of Coyote Creek, December 2005.

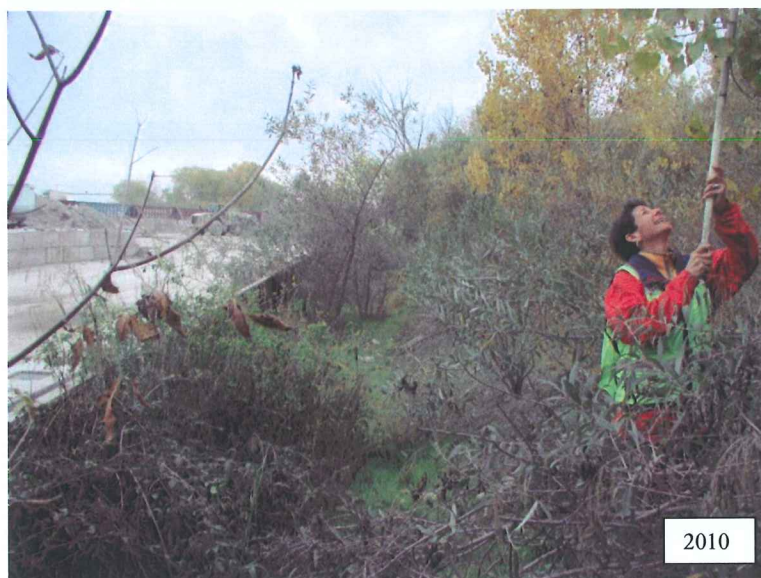
Figure 5B. Photo Station #1, taken from southern end of revegetation area, looking northward along the top edge of Coyote Creek, December 2010.

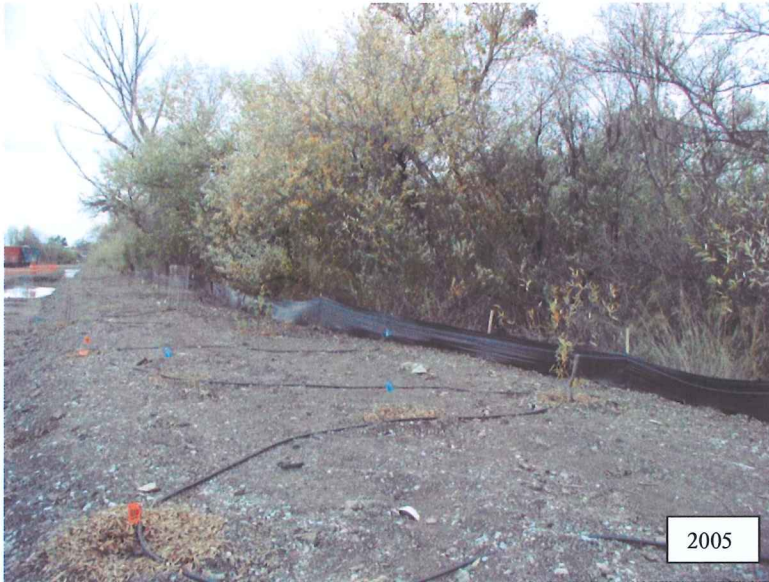
Figure 6A. Photo Station #2, taken from mid section of revegetation area, looking eastward toward top edge of Coyote Creek, December 2005.

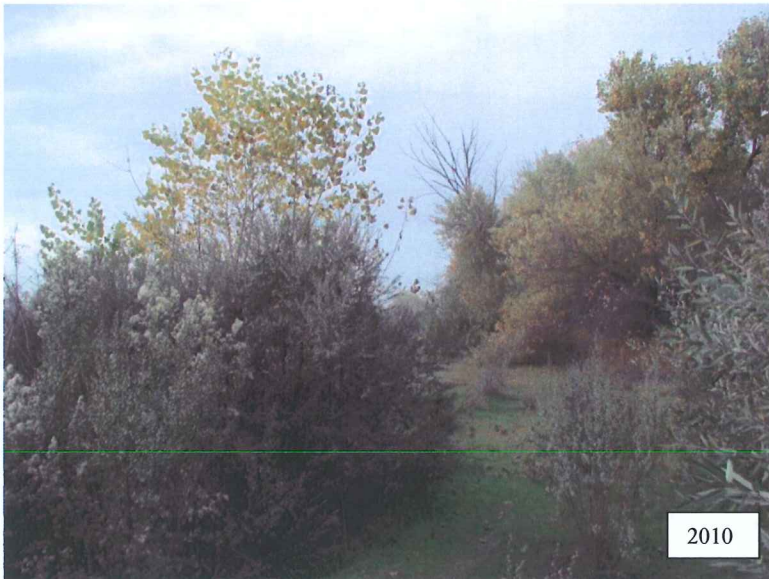
Figure 6B. Photo Station #2, looking eastward along top edge of Coyote Creek, December 2010.

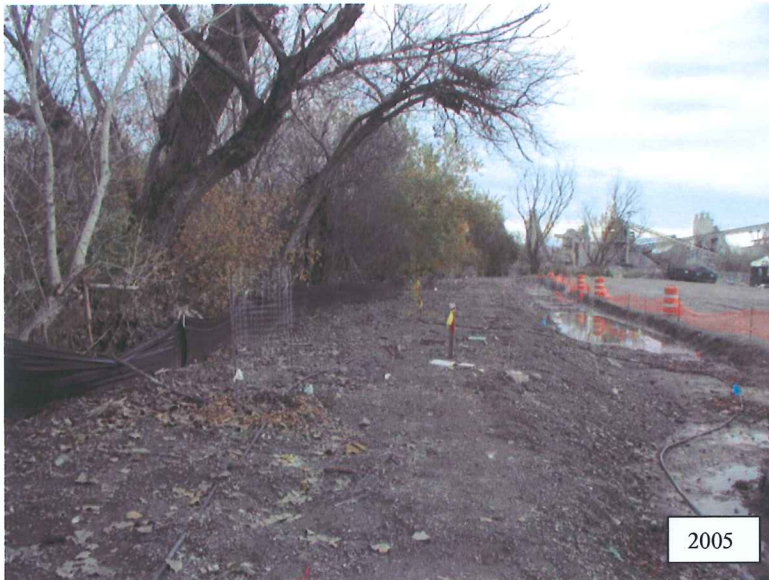
Figure 7A. Photo Station #3, taken from mid section of revegetation area, looking southward along the top edge of Coyote Creek, December 2005.

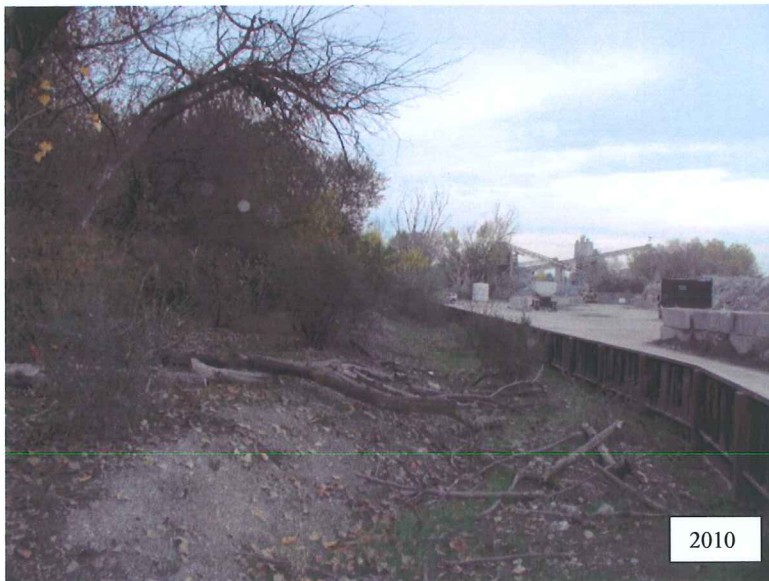
Figure 7B. Photo Station #3, looking southward along the top edge of Coyote Creek, December 2010.

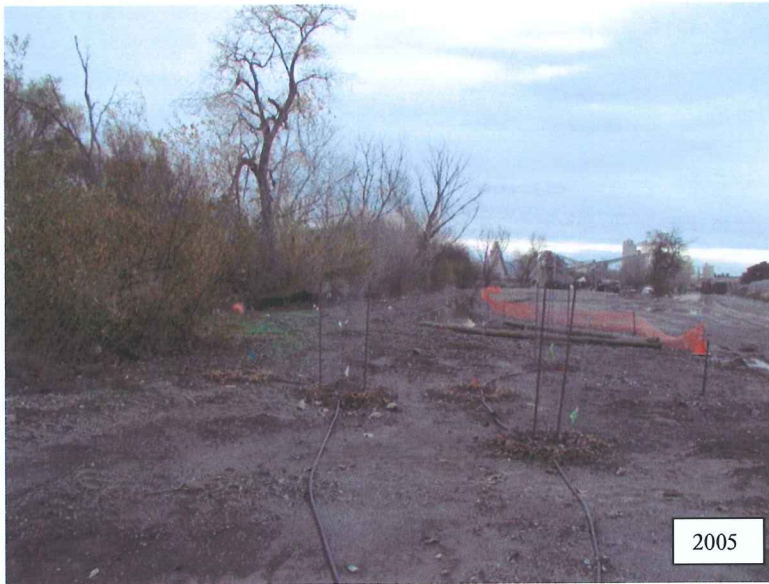
Figure 8A. Photo Station #4, taken from northern end of revegetation area, looking southward along the top edge of Coyote Creek, December 2005.

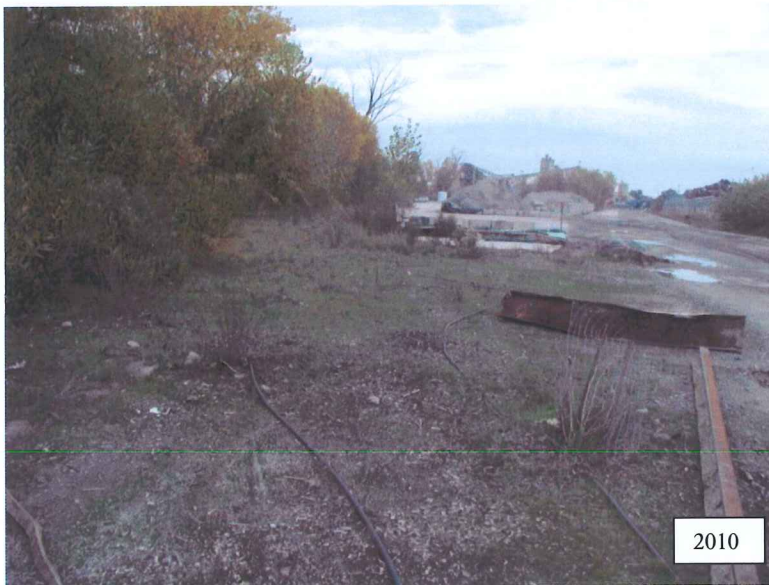
Figure 8A. Photo Station #4, looking southward along the top edge of Coyote Creek, December 2010.
